GOVERNMENT MODEL HIGH SCHOOL (GMHS), SECTOR- 25 B, CHANDIGARH

SUBMITTED BY:
SAFETY CIRCLE PRIVATE LIMITED

Comprehensive Audit for School Safety

Chandigarh Commission for Protection of Child Rights,
Maloya, Chandigarh

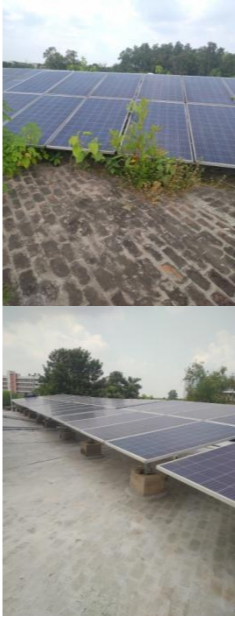
It was observed that the school did not have a NOC from any electrical inspector. Only an energy bill was available. Electrical Load of one meter was 39.170 KW and the other was 45.680 W Solar panel was installed on the roof of the school but not maintained in a proper manner. In one building the solar was unconnected.	It is recommended to the school that a valid NOC from an electrical Inspector is required under Regulation 2D of Electricity Supply Act 2010. It is recommended that school should provide the actual energy consumption bill with updated Solar load and solar should be properly maintained so that they can Generate Electricity as per Installed Capacity	High

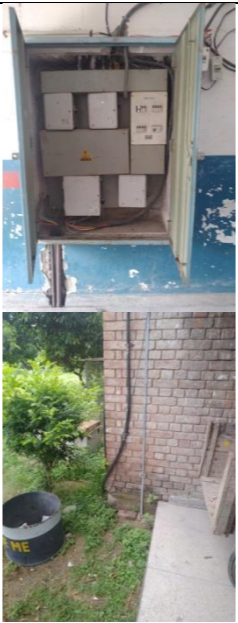
3.	Are there any uncovered live wires?	Visually	Visually checked

It was observed that some uncovered live wires were found in Electrical panel Some 3-P 440 Volts cable inside the premises were laid without Pipe.	It is recommended that all the wires inside the premises should be in a well-insulated and conduit manner.	High

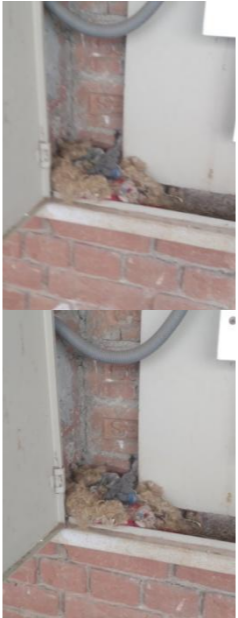
10.	Are the wire entries done safely?	Visually	Visually checked

It was observed that many cables and wires were positioned in an improper manner, without conduit, inside the electrical panel.	It is recommended that all the wires should be installed in the electrical panel in a safe manner with proper conduit as per IS 732:1989.	High

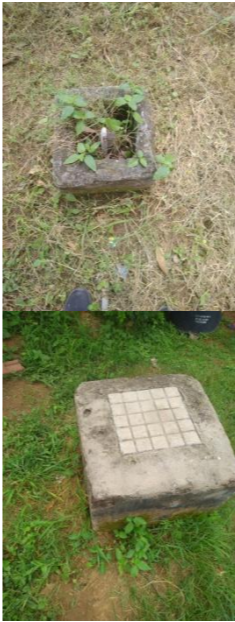
14.	Is a grid type earthing system available?	Visually	Visually Checked

It was observed that earthing pits were available but not maintained.	It is recommended that the earthing system should be in grid, as per IS 3043:1987.	High

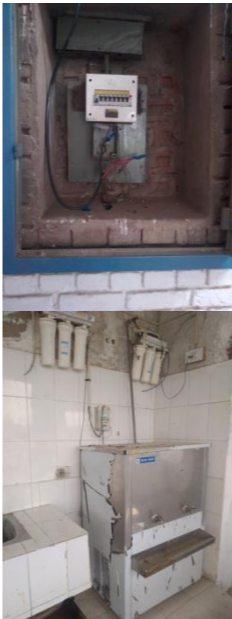
22.	Are switchboards/ main switches working properly? Are the switchboards covered and cautioned?	Visually	Visually Checked	N.A

It was observed that the switchboards/ main switches were not working properly and were not covered and cautioned, which offered electrical hazard.	It is recommended to the school to ensure that all the switch boards / main switches are working properly, and the switch boards should be covered and cautioned properly as per IS 1956.	High

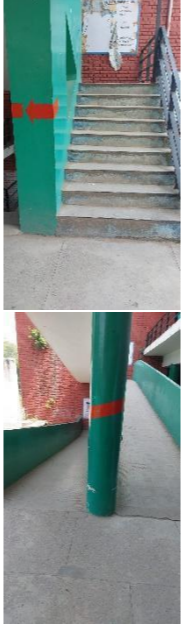
6.	Are there dual entry or exit routes in the building?	Visually	Visually checked

It was observed that as per physical round school buildings had dual entry or exit routes available and school building blocks and all buildings were connected with each other.	It is recommended to ensure that the same conditions are met in the future also.	Low

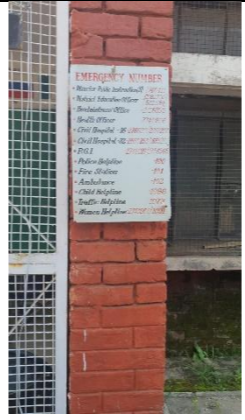
3.	Are the important telephone numbers of administration displayed at the entry point and near the administration office of the school?	Visually	Visually checked

During the audit, it was observed the important telephone numbers of the administration were displayed at the entry point in the school premises.	It is recommended to the school to ensure that the same conditions are met in the future.	Low
4.	Are the staff aware about first aid safety for trauma?	Interview	Interaction with coordinator	N.A	It was observed during the audit that the school staff was not trained in first aid safety for trauma.	It is recommended to the school that at least the key staff members should be trained in first safety for trauma.	High

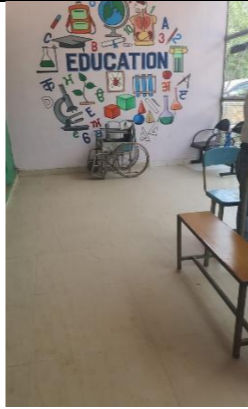
It was observed during the audit that a wheelchair was available in the school.	It is recommended to the school to ensure that the same conditions are met in the future.	Low

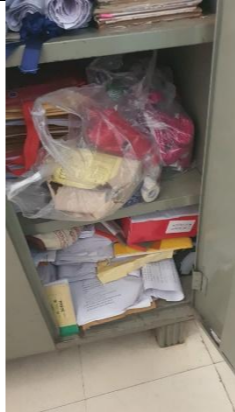
It was observed during the audit that the school had adequate first aid supplies but they were not kept properly.	It is recommended to the school that all the first aid material should be kept properly.	Low

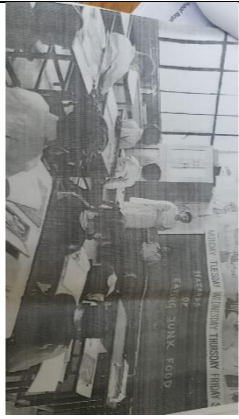
16.	Is health education provided to students on various health issues including balanced diet, nutritious alternatives to junk food, regular eating habits, personal hygiene, etc.?	Visually/ Document	Photographic evidence

It was observed during the audit that health education was provided to students on various health issues including balanced diet, personal hygiene, and alternatives to junk food.	It is recommended to the school to ensure that the same conditions are met in the future.	Low

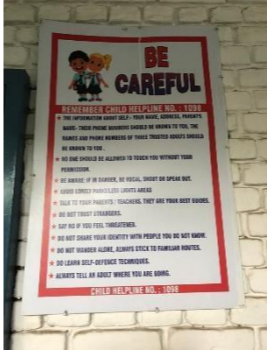
3.	Is the Child Protection Policy summarized and displayed at the reception or main lobby area of the institution along with the 1098 child helpline number, and is it available in English as well as in Hindi?	Document	Document not available

It was observed during the audit that there was no Child Protection Policy created or implemented by the school but there was a child protection committee in the school. It was not summarized or displayed anywhere in the school.	It is recommended to the school that the school should create and implement the child protection policy. The policy should be summarized and displayed at the reception or main lobby area of the institution along with the 1098 child helpline number.	Medium

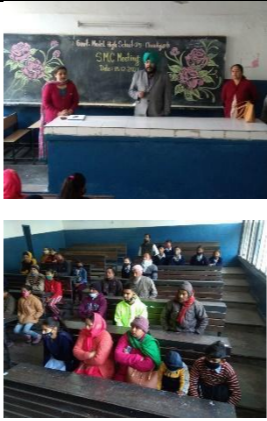
7.	Are parents and students sensitized from time to time on the Child Protection Policy/Guidelines/child laws and reporting mechanisms?	Document	Photographic evidence

It was observed during the audit that Parents and students were sensitized from time to time on the child protection policy/ child laws and reporting mechanisms.	It is recommended to the school to ensure the same conditions are met in the future.	Low

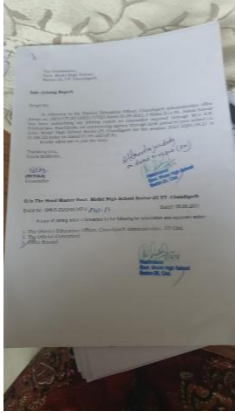
13.	Does the school have a qualified Child Counsellor/Psychologist – part time or full time or on-call consultant who can be accessed when there is a requirement related to a mental health related emergency?	Document	Document checked

It was observed during the audit that the school had a qualified child counsellor (Nitika) (M.sc in applied psychology)	It is recommended to the school to ensure the same conditions are met in the future.	Low

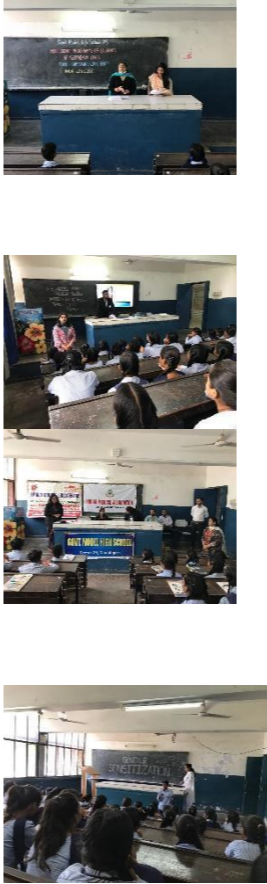
steps to be taken w.r.t child sexual abuse	conditions are met in the future.	
16.	Does the school conduct awareness programs to sensitise students on harms of substance abuse, mutual and peer respect, gender sensitivity, social responsibility; and consequences of behaviour or action, including penalisation under law such as JJ Act, 2015 and POCSO Act, 2012?	Document	Photographic evidence

It was observed during the audit that the school counsellor conducted awareness regarding the harms of substance abuse, gender sensitivity, social responsibility including POCSO Act.	It is recommended to the school to ensure the same conditions are met in the future.	Low

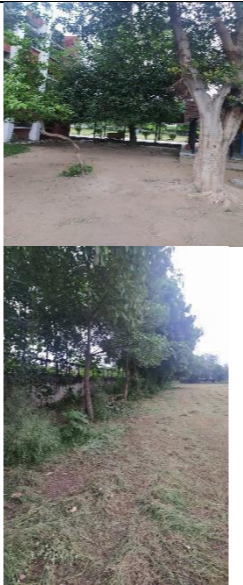
1.	Is the school identifying old trees or the trees which have a risk of falling?	Visually	Visually checked

During the audit it was observed that Sheesham, mango, pilkhan, big Eucalyptus and shahtoot were some old trees standing in the backside of the school lawn.	It is recommended that the trees should be pruned of extended branches or removed.	Medium

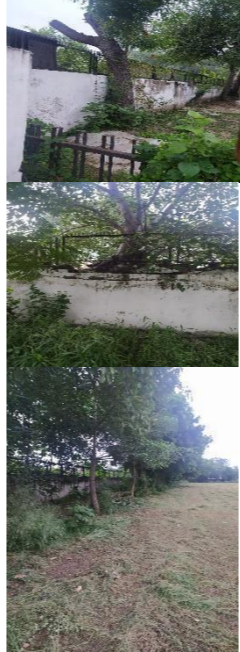
10.	Is the school ensuring that there is no wild growth in and around the school premises?	Visually	Visually checked

It was seen during the audit that wild growth existed all along the boundary wall around the trees, but the lawn area had recently been cut and the cutted grass was lying on the ground.	It is recommended to do proper pruning of any such wild growth.	Low

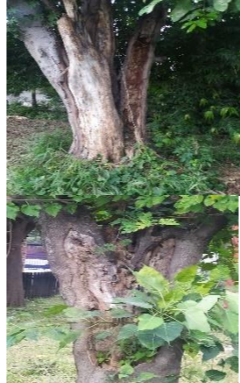
12.	Are the trees in healthy condition, free from any disease, insect pest or any physical damage / disorder?	Visually	Visually checked

It was observed that the trees along the boundary wall were in healthy condition whereas few trees like ceiba, papri, neem were stem borer affected.	It is recommended that all the affected trees be removed as they are dangerous.	Low

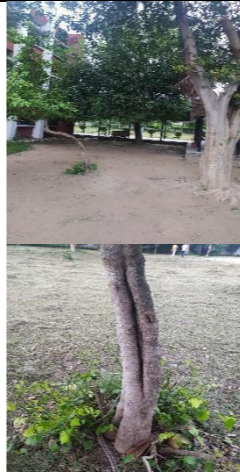
13.	Are the trees standing in a balanced position?	Visually	Visually checked

It was observed that the trees were having bent stems.	It is recommended that they should be removed or pruned on regular intervals.	Medium

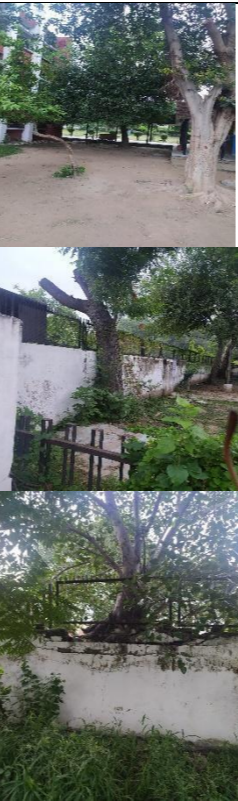
15.	Have the trees grown too large that it might cause damage to life and property?	Visually	Visually checked

<p>It was observed that the silver oak tree was too high and needed pruning, and the shahtoot tree required pruning.</p> <p>The outside boundary wall was bending inwards. Neem tree was touching the front boundary wall near the gate & breaking it .</p> <p>Shehtoot had been affected by the stem borer and had to be removed. Bael was bending on side pruning.</p>	<p>It is recommended that the silver oak should be pruned till 25 ft and other trees should be pruned according to their length and some should be removed which has been bending.</p>	Medium
